FISHERGATE POSTERN TOWER

YORK

HISTORIC BUILDING RECORDING

**REPORT
DECEMBER 2009**

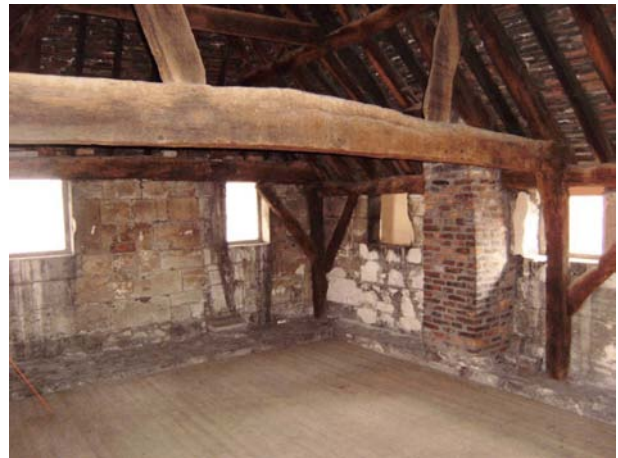
Plate 6 Roof structure

The roof consists of a timber-framed two-bay structure formed within the masonry parapet of the tower (Figure 2; Plate 6). The structure is supported on six posts, located at the corners and mid-point within the parapet walls. That in the southeast corner has been removed. Curved braces from the posts support the wall plates, one brace has been removed from the mid-post on the east side of the building (Plate 7) in addition to a further brace which would have joined with the absent corner post.

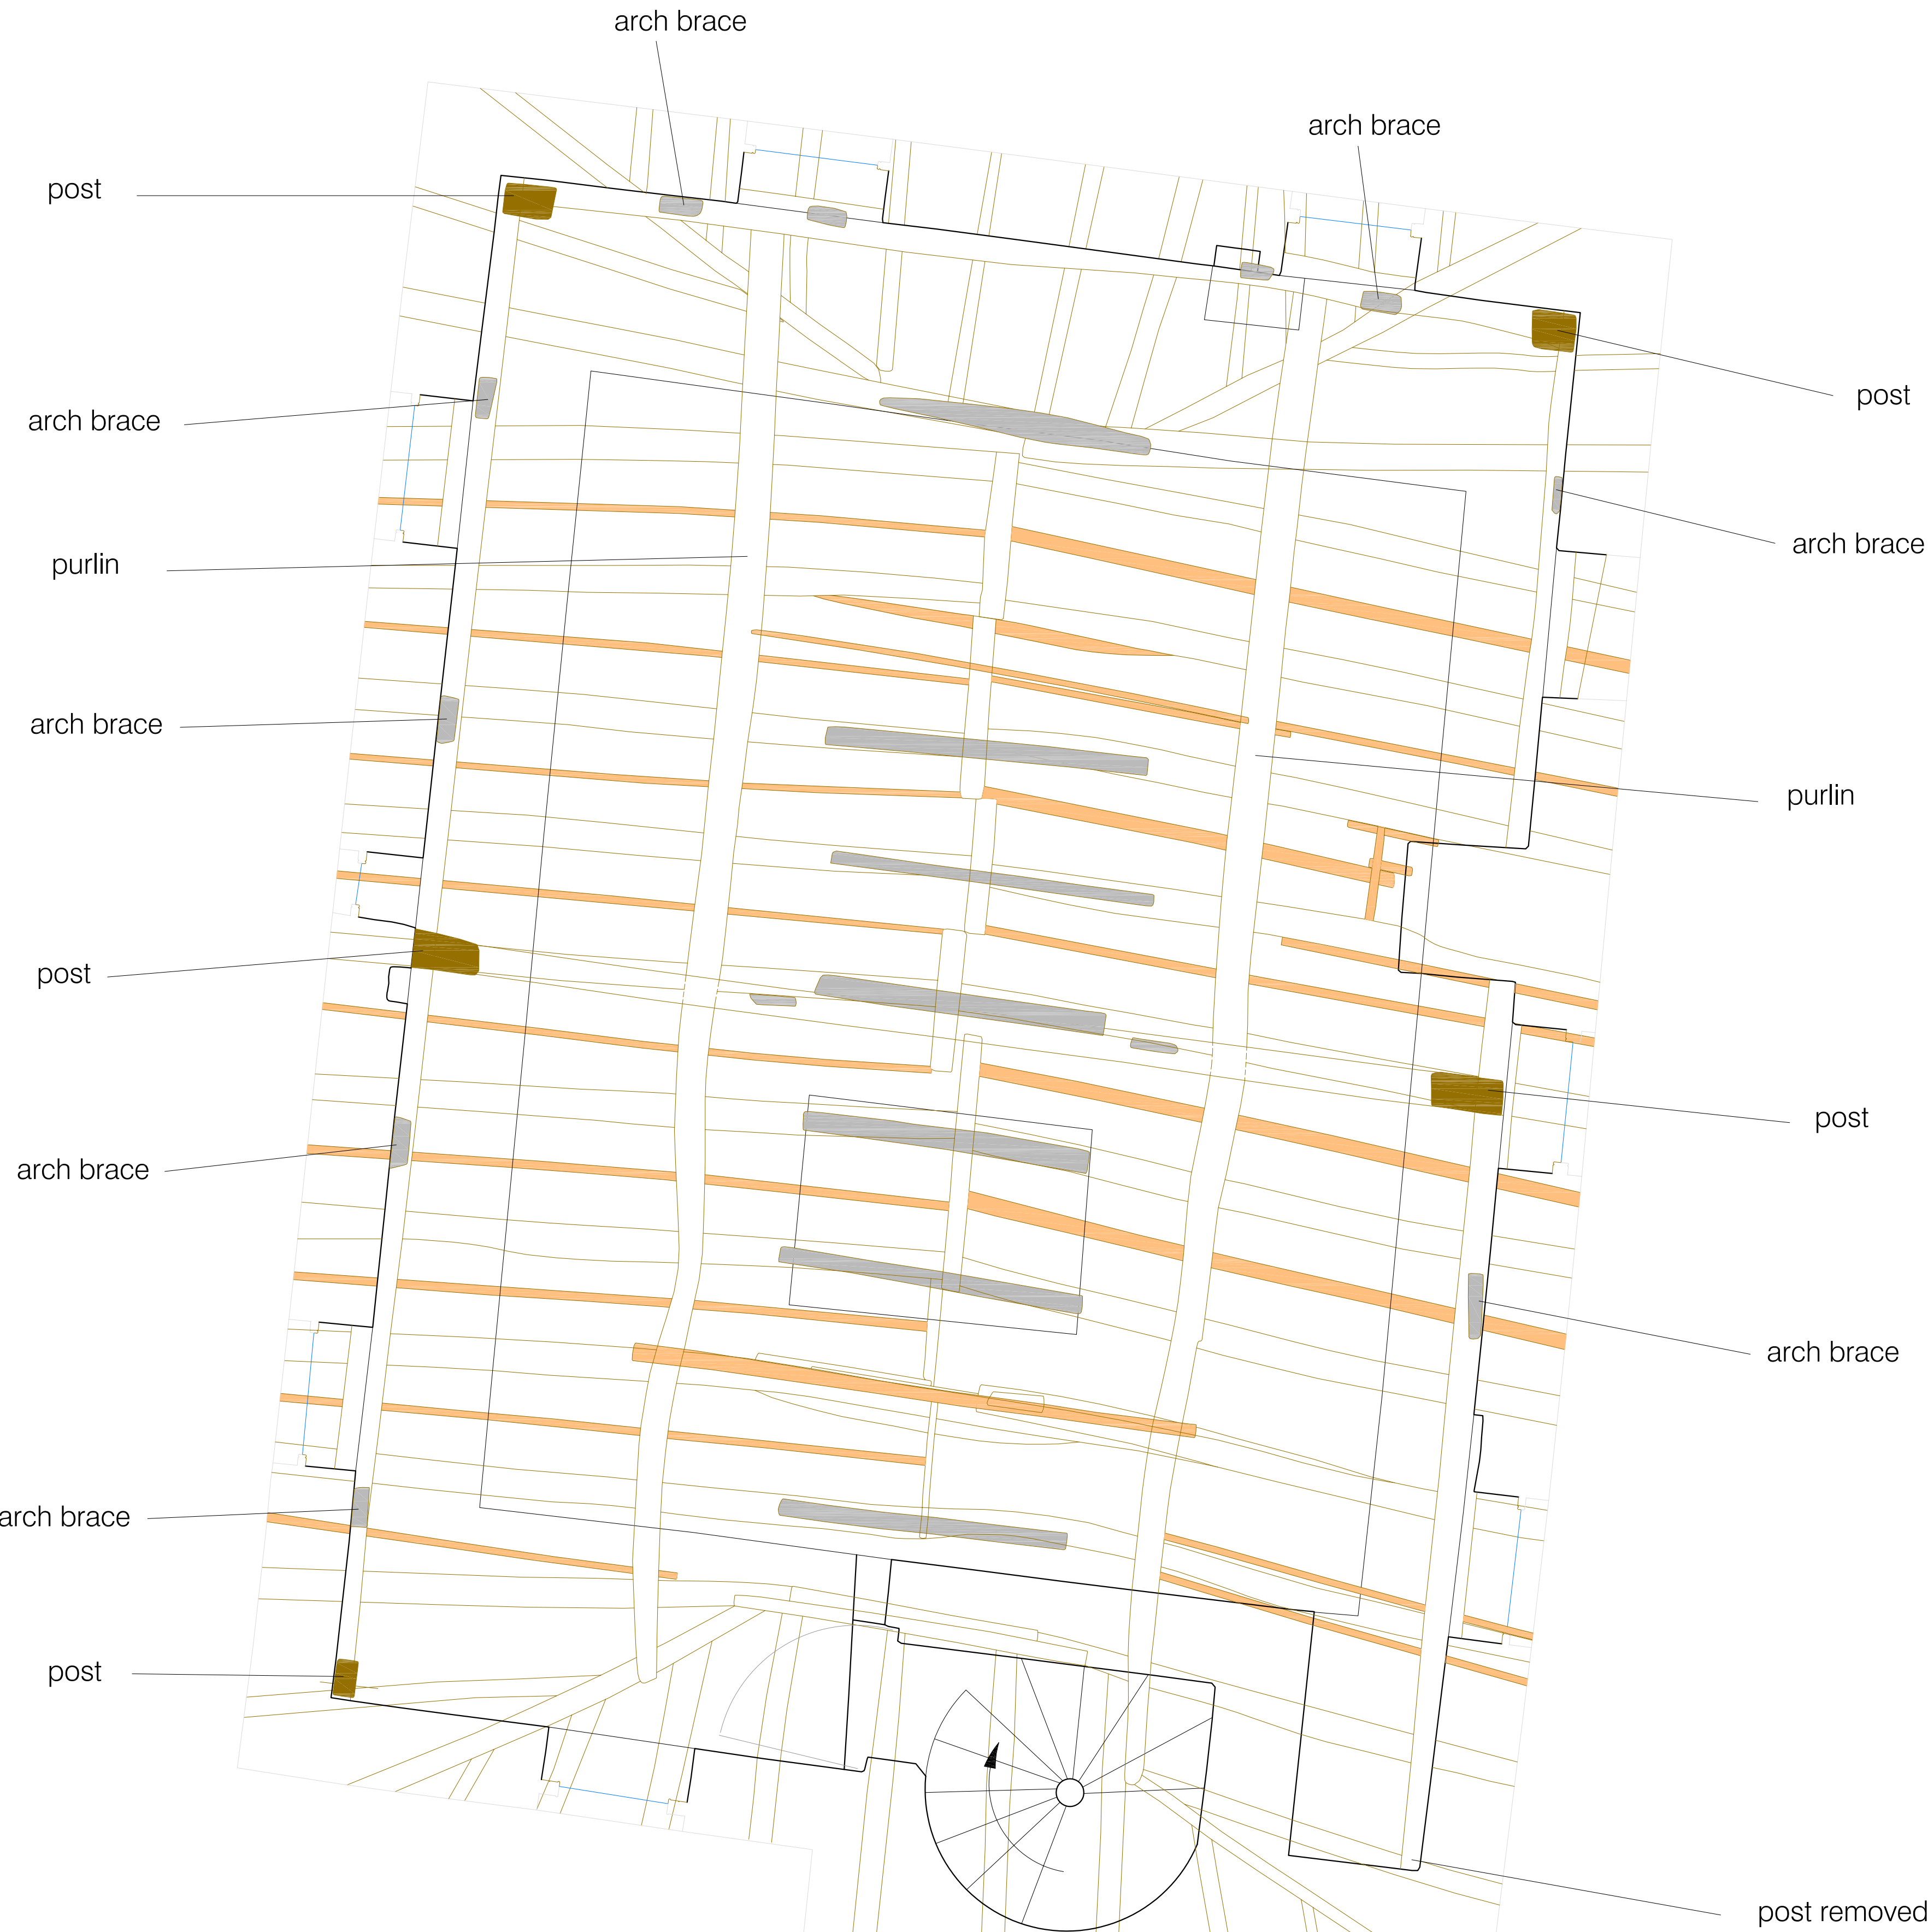
Reflected Roof Plan

In general the current roof structure appears to have been erected in one event with only minor subsequent modification. The main alteration consisted of additional common rafters being inserted between the originals which were spaced at intervals of *c.*0.4m (see Figure 2). The replacements were inserted equidistantly between the originals. This repair might have been undertaken in *c.*1740 when substantial works were apparently undertaken to the roof, including new tiles.

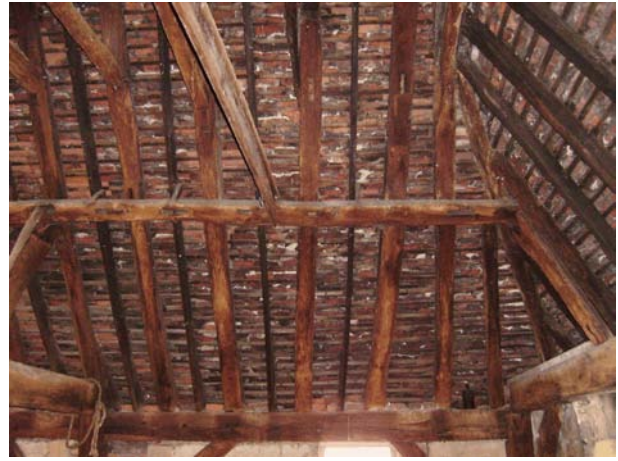
Plate 9 Roof purlin showing mortices

The purlins appear to have been rails or wall plates from a timber-framed building with regularly spaced mortices cut into them, many still retaining pegs (Plate 9). They are of considerable length at *c.*7.0m, and have evidently come from a building of some size. Their length would preclude them from having formed part of the original roof, timbers for which would not have exceeded the internal length of *c.*5.5m. The struts are also of reused timbers and have grooves in their sides indicating they are from a timber-framed building which had daubed in-fill panels.

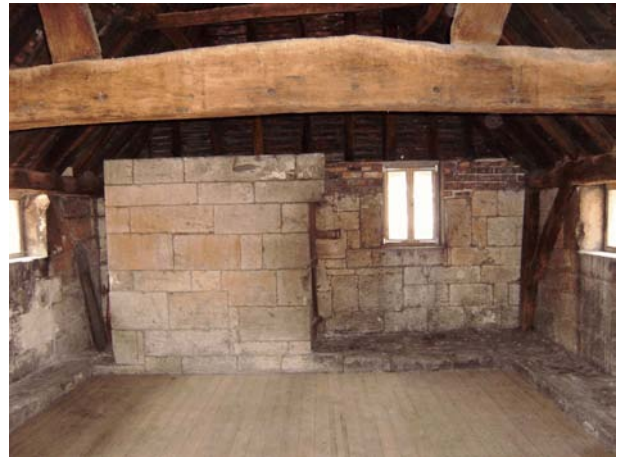
Plate 10 Peg holes in tie beam

The central tie beam has redundant mortices in its upper surface and peg holes through its vertical faces (Plate 10). The peg holes generally do not relate to the mortices. It is possible that these features were intended for a partition wall, with the mortices serving to take studs above the tie beam and the peg holes to take face pegged studs below. However, there is no evidence that if studs were inserted in the mortices that their upper ends were fixed to either the braces or rafters. It can only be concluded that the tie beam is also a reused timber in its current context.

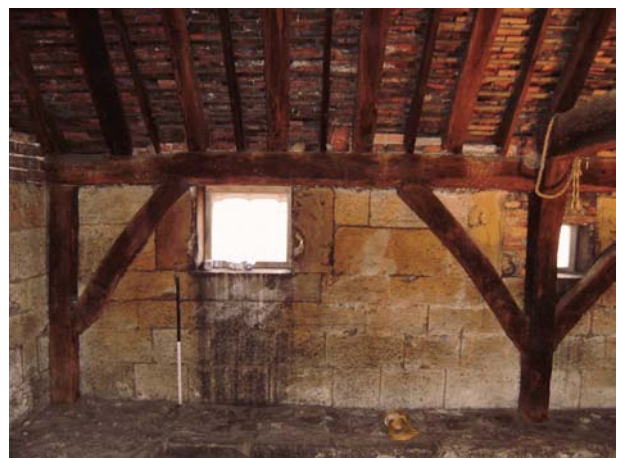
Plate 11 Wall plate

Although the west and east wall plates are too long to have come from within the tower they show little evidence for reuse (Plate 11). The same situation pertains to the posts and arch braces, where there is little evidence for reuse. It is therefore highly likely that these timbers were cut for their current application in the structure.
